Rebuilding a 1937 Morris 8 Sports

Episode 2: Running boards

Running board condition and initial preparation

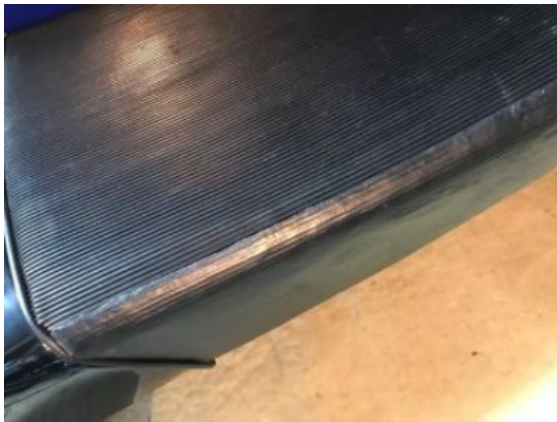
A section of the finished LHS running board.

The rubber tread sheet was roughly cut to size. It was cleaned with solvent (MEK/Acetone) to remove any traces of the extrusion die releasing agent. The rubber was then bonded to the painted metal surface as follows. A reasonably thick layer of Ados F2 contact adhesive was first brushed on to the rubber sheet and left to touch dry. The degree of drying is not critical, and in practice thinner parts dry much faster than thicker. While the contact adhesive was drying, an even coating of flexible waterproof black urethane adhesive was applied to the running board surface (it comes out of the gun applicator tube in a thick

The F2 coated rubber sheet was brought into contact and moved around until positioned and aligned as desired. Any adhesive lumps or air bubbles were smoothed out. A small roller is useful here. Modest pressure was then applied over the profiled horizontal running board surfaces by inverting it on a suitable reverse profile (you may achieve a better job if you construct something suitable although I just used old blankets, etc.).

This was buffered with a 50mm foam sheet to spread

The pressure across the surface of the sheeting. The metal underside was then loaded

with as many heavy objects as necessary in appropriate places to achieve a reasonably even pressure.

The sides and edges were then smoothed down and clamped (with whatever you can find - clothes pegs, croc clips, woodworking clamps etc.) until the polyurethane was cured enough to stay bonded (~2 days to be sure).
