NOW YOU HAVE IT - NOW YOU DON'T, SYNCROMESH THAT IS

Contributed by: Peter Simpson, Lower Hutt

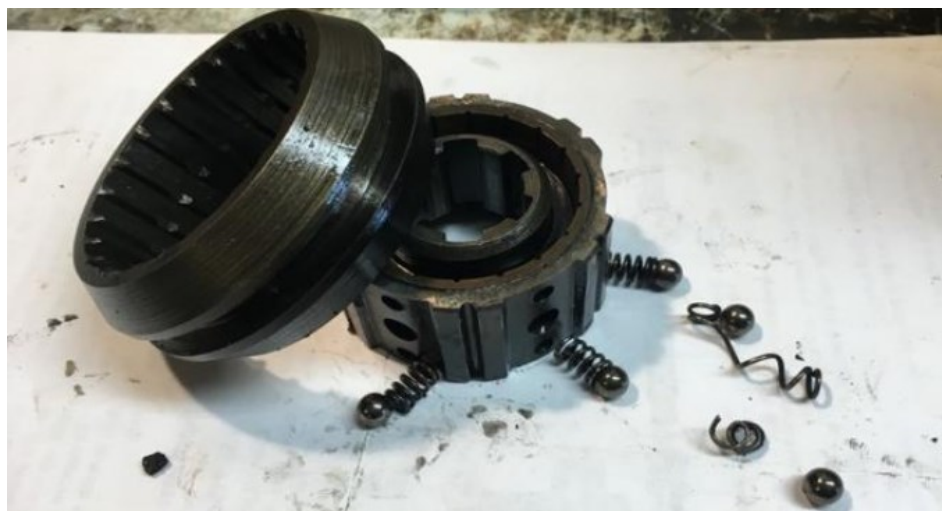
That's the bits of spring found plus the two ball bearings. I have no idea where the rest of the springs or the 3rd ball bearing had gone as there should be in total six springs and ball bearings. They were never found. Three of the springs and ball bearings shown are lined up with the holes within which they reside.

In conclusion, I can only guess that the three springs had disintegrated over time. One had probably broken and ejected its ball bearing which came out unnoticed in an oil change and the other two finally gave up and also parted company from the synchro unit. I had noticed that there was some gear crunching increasing over the last couple of years so the badly worn brass (?) lining and broken spring may have been the first signs of trouble in the synchro unit.

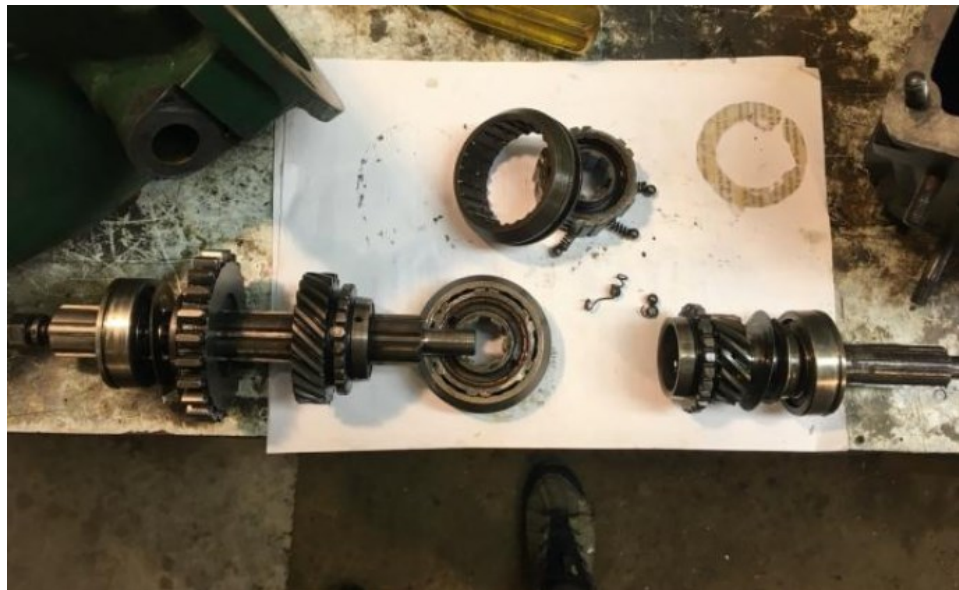
Showing the position of the replacement synchro unit position on the shaft with the old unit at the top

Fortunately, I had a couple of gearboxes lying around so they were gathered up and likewise disembowelled to extract the synchro units. A good unit was assembled from all the various parts and fitted onto the main shaft. A word of advice is to also check the brass (?) lining of the synchro unit for wear and pick the least worn as this part is vital for silent gear changes. And yes, you too can have fun getting the six springs and ball bearings into their respective holes while getting the outer ring mechanism on. (Hint, use a suitably sized jubilee clip or a piston ring compressor if you can get your hands on one, otherwise you can expect

all six springs and ball bearings to be forcefully expelled to the far nether regions of your garage never to be seen again. I prevented this by assembling the unit inside a bag to catch any escapees while manoeuvring the jubilee clip and outer ring. While the box was apart, I used this opportunity to replace the main shaft bearings with new ones.
