Morris Eight Oil Leaks, and the Vexed Question of Scrolls

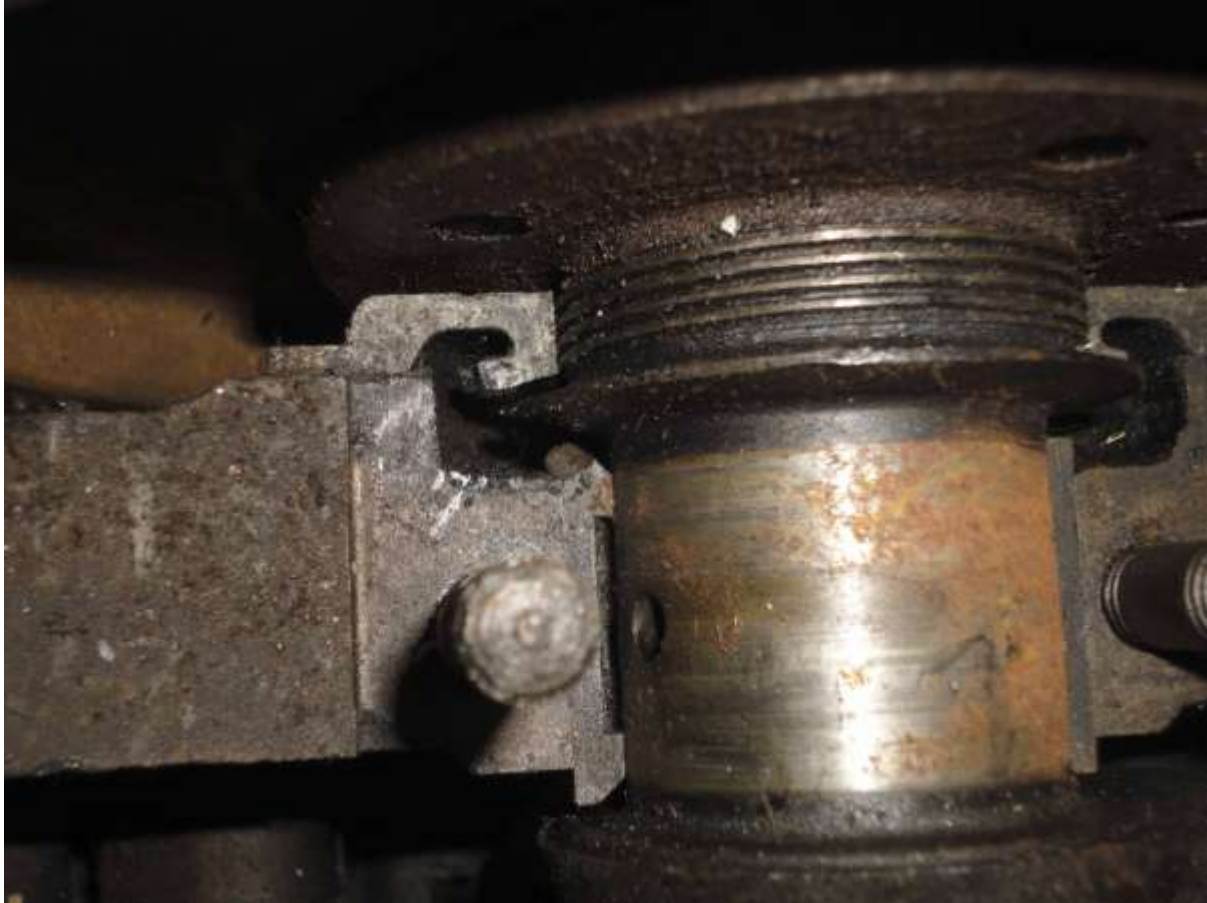
Position of scroll relative to segment

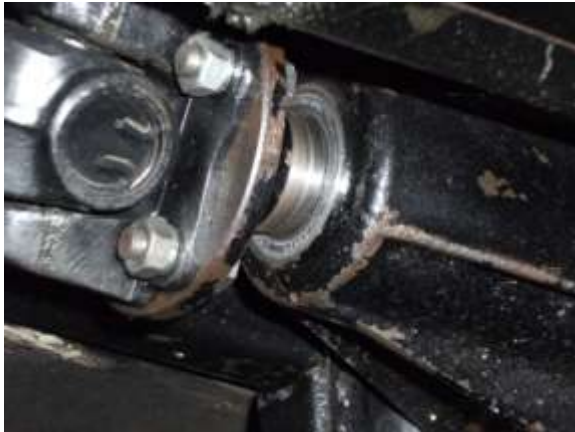
4-speed gearbox modified for lip seal

A permanent solution is possible for both gearbox and diff, because it’s a fairly simple job to convert to modern lip seals by machining off the scroll and machining a recess to suit an appropriate seal in the housing or cover. On the gearbox this may also be done at the front end by machining the detachable cover containing the felt seal. While such procedures may offend the purist by departing from original, they are relatively simple and virtually invisible

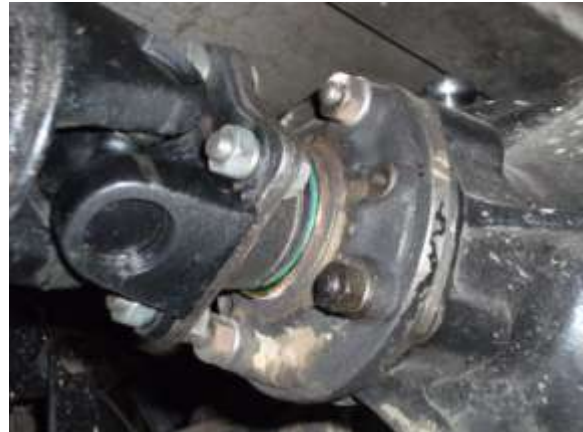
Differential modified for lip seal

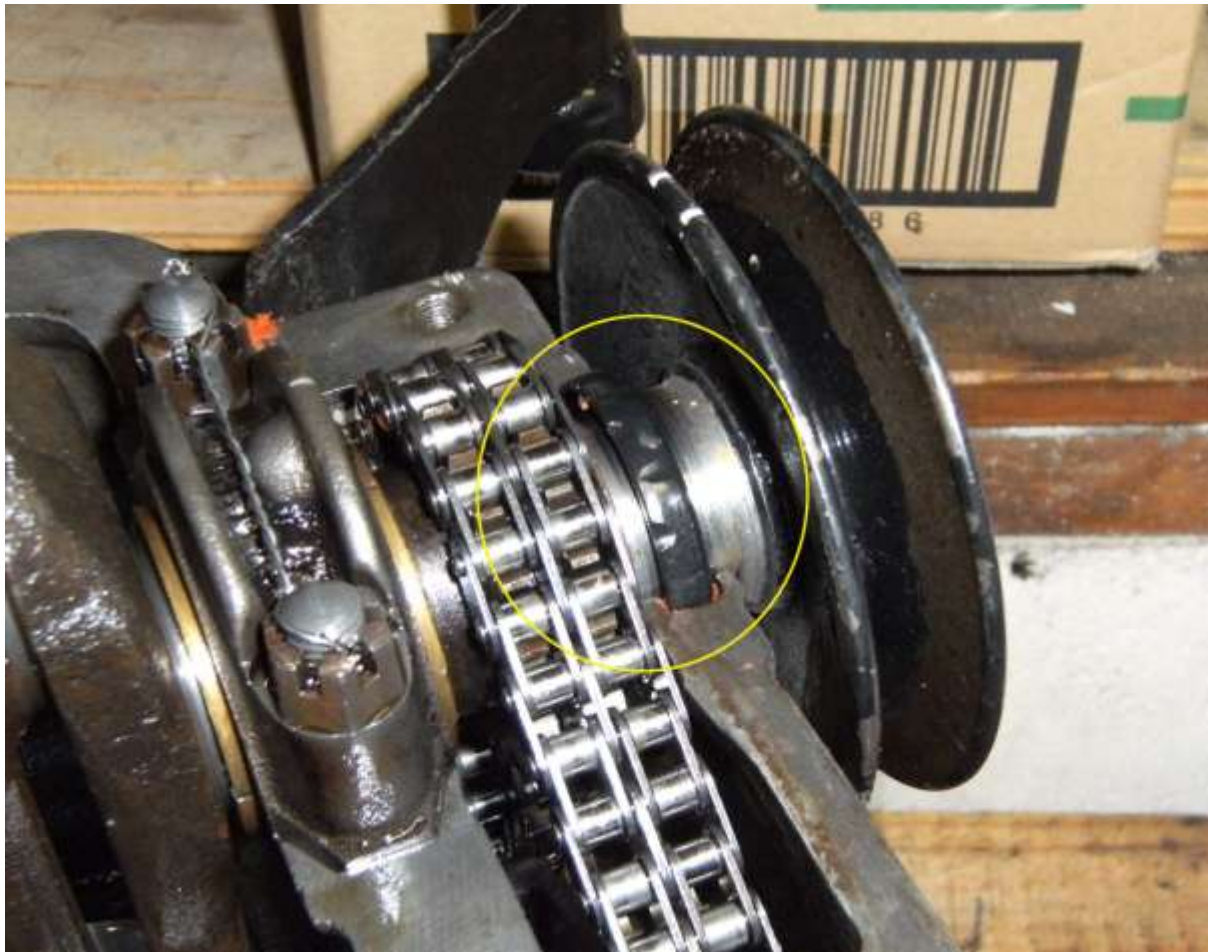
Once again a fairly easy solution in the form of a lip seal is possible. There are two ways of tackling this: either the grooves could be machined to fit the seal; or a seal with smaller outer diameter can be used, packed out and set in place by high-temperature red silicone sealer. The latter method, while less elegant from an engineering standpoint, eliminates the need for expensive and tricky machining, and works just as well; an example is shown in the picture below. Note that small notches have been filed into the outer rim of the seal to aid retention by the surrounding silicone and ensure it doesn't turn with the crankshaft.

The sole drawback with this arrangement is that it makes sump removal and replacement more difficult; but how often does that need to be done? With a proper seal at the front, careful assembly of the gaskets, and regular oil changes it should be required only at long intervals—probably several years, at the very least, with the sort of annual mileage most of these cars accumulate. Personally I won't attempt it with the engine in the car, not least because the task of fitting the sump and its assortment of gaskets with the degree of care and precision needed to ensure reasonable oil-tightness (discussed below) is much less likely to succeed when undertaken while lying on your back under the car with oil dripping onto your face, regardless of what type of sump/timing cover seal is used.

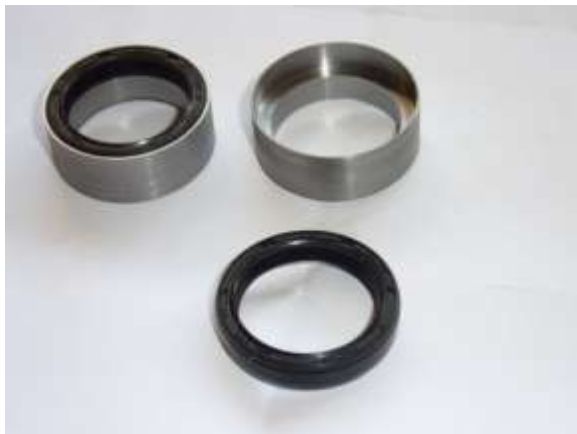
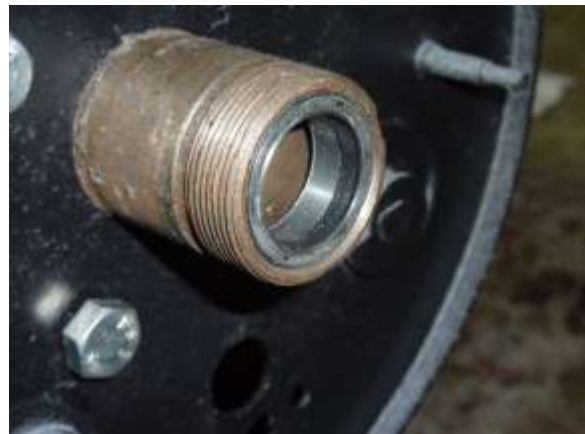
The cork half-shaft seals feature an internal scroll groove to help restrain oil from getting out, but as with the pinion shaft this works in the opposite sense when the car is reversed, so it makes sense to reverse the car as little as possible. Having found the cork seals ineffective during my early Morris years, and new replacements no better, I switched to a lip seal modification which in my view is a significant improvement. This involves making an adapter bush to fit the internal diameter of the axle tube and accept a 1 x 1 1/4 x 1/4" lip seal; shown below are those Dave Lawton made for his Series E. On the earlier Eights it's advisable to mount the seal further into the axle housing to be clear of the hub splines.

Wherever a lip seal is used it's vital to ensure that the knife edge of the lip is running on a perfectly smooth surface, so the shaft in this area should be polished to a fine finish. Lip seals are easily damaged, and these ones will be if care is not taken to protect them from the tendency of the splines at the diff end of the shaft to wear fine, sharp edges in normal operation, which could cut the seal lip when the shaft is withdrawn. This can be overcome by partially withdrawing the shaft and then feeding a strip of thin oiled paper wound spirally around the shaft under the seal, before withdrawing the shaft through the paper. Needless to say, this precaution should also be taken when installing the shaft. Colonial members in Australia, New Zealand, or Canada will find the best material for this is a bank note, since these are printed on a plasticised base that's thin, tough, and slippery, from which the oil is easily cleaned off. I understand these will only be available in Sterling sometime next year (2016).
