Morris 8 - Special Tools

In the last of the series of articles on the Morris 8 tool kit, I will be reviewing the special tools that were available from the Morris dealer.

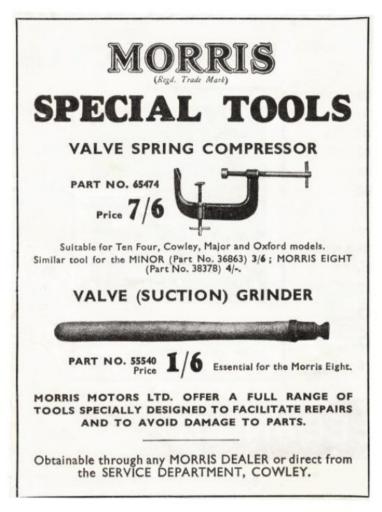
When I started my research into Morris 8 tools. I noticed there were two "extra" tools listed in the parts list, along with the rest of the actual tool kit. They were the valve spring compressor and the suction valve grinder. I initially thought the Morris Motors included them with the car. However this was not the case, instead they could be purchased from a dealer by owners wishing to do their own decarb and valve grinds. Fig. 1 shows an advertisement which occasionally appeared in the Morris Owners magazine during the mid 1930's. It communicated to Morris owners that specialty tools were available from Morris Dealers. (Note - the valve spring compressor illustrated is for the Ten Four, Cowley, Major and Oxford models).

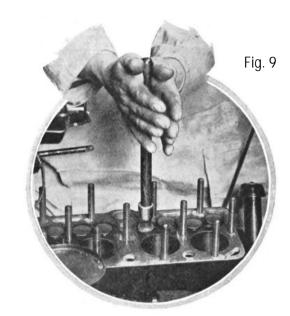
In the Morris General Service Information manual, section G21, is a picture (fig. 10) of suction valve grinder pt. no.

66893. Comparing this picture with the previous, show only subtle differences in the shape of the handle and rubber suction cup. Since they both do the same job and fit the same component, it's a mystery why there was a change in part numbers, perhaps there was a change in supplier.

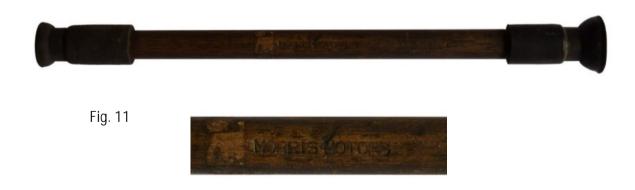
Morris Motors were known to have stamped their name on some suction valve grinders (fig. 11). Whether this was the case with pt. no. 55540 & 66893 is unknown.
