# Remobilisation of a 1937 Morris 8 Sports

## Episode 5: Starter Motor Dilemma

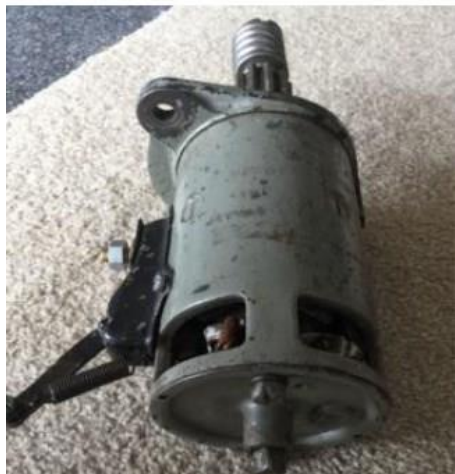
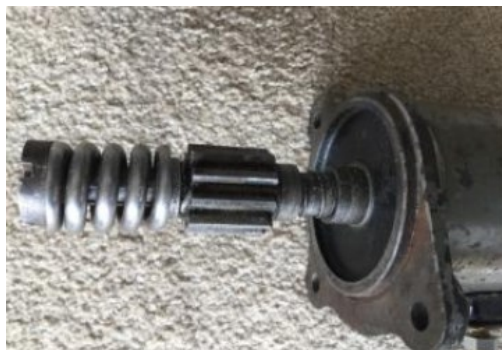
*The fitted starter motor with integral manual switch and 3-hole mounting flange.*

This then fully disassembled, and bearings, etc., checked and cleaned. All seemed to be in order. There was a little bit of play in the bearings, but nothing excessive. The current return path from the ground side brush through the end plate, motor frame and mounting flange appeared to be somewhat corroded, so this was rectified. Brushes were half worn, but looked fine. The engagement pinion and ring gear on the flywheel seemed to be in reasonable condition. The starter motor spun up to high speed when connected unloaded to the battery, taking about 27A at ~5V. Back it went into the car, but the result was again the same.
