MORRIS Z UTILITY RESTORATION

1951 Morris Z Convertible Utility.

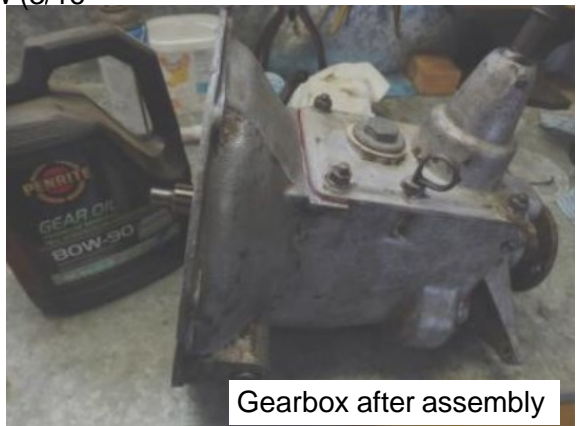
Gearbox after assembly

The gearbox bearings ordered from G.B. did not fit, but I had some ordered in by a helpful local supplier. The wrong bearings were credited at a return postage to G.B. of \$31. The cluster bushes were sawn out with advice and help from Tony Basham. Of course, after pressing in the new bushes the shaft would not fit in.

Fortunately, a local firm reamed the bushes, straightened the lay shaft, made new bushes for pedal shafts and fabricated new striker plates for the doors. A screw (3/16 B.S.F thread) which retained the lay shaft in the gearbox case was sheared off at both ends.

The existing was drilled and removed with an Easy-out, then drilled and tapped to take a 1/4 A.F. bolt.

Assembly of the gearbox was then straightforward, and a Loctite compound was used in place of gaskets.

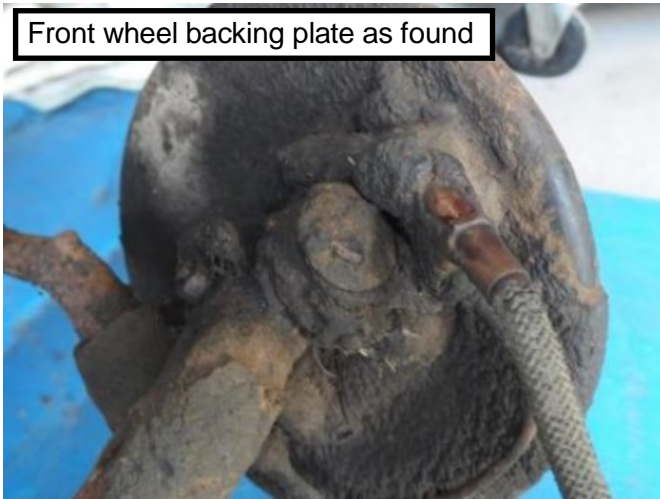
Front wheel backing plate as found

Backing plates complete with brakes were unbolted and kingpins driven out. A few days were

occupied disassembling brake shoes and pistons, cleaning all and painting backing plates.

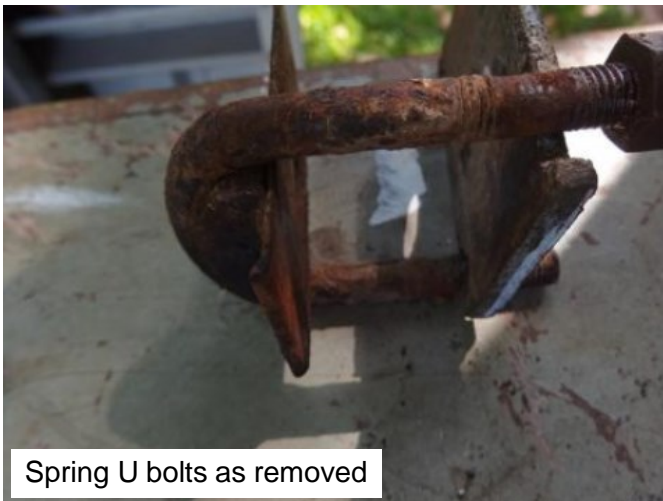
Spring U bolts as removed

The brakes were disconnected, steering draglink removed, track rod disconnected, front shackle bolts knocked out and rear shackle pins removed. The assembly could now be lowered to the ground and spring U bolts removed.

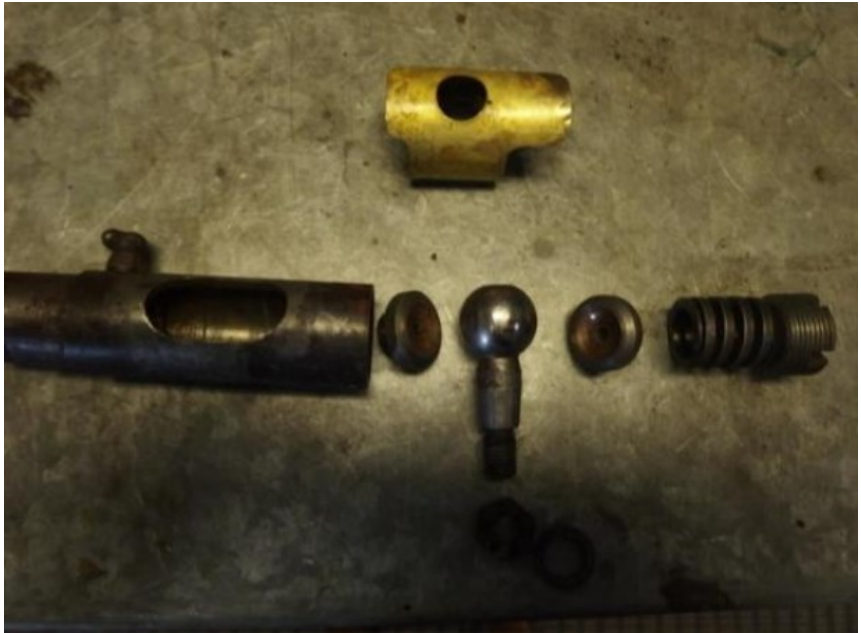
The drag link was disassembled, cleaned and put together with fresh grease.

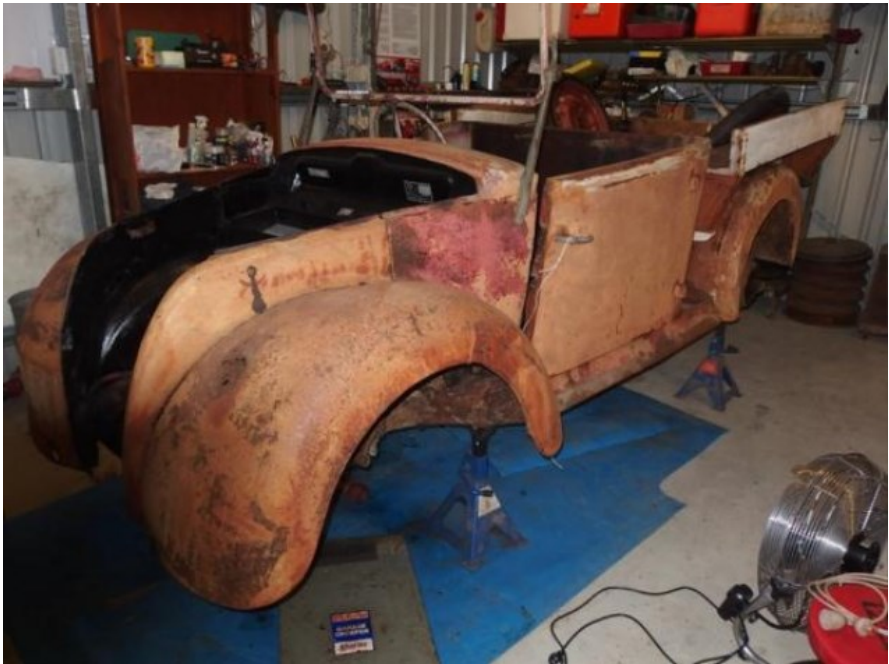
Utility now without front suspension

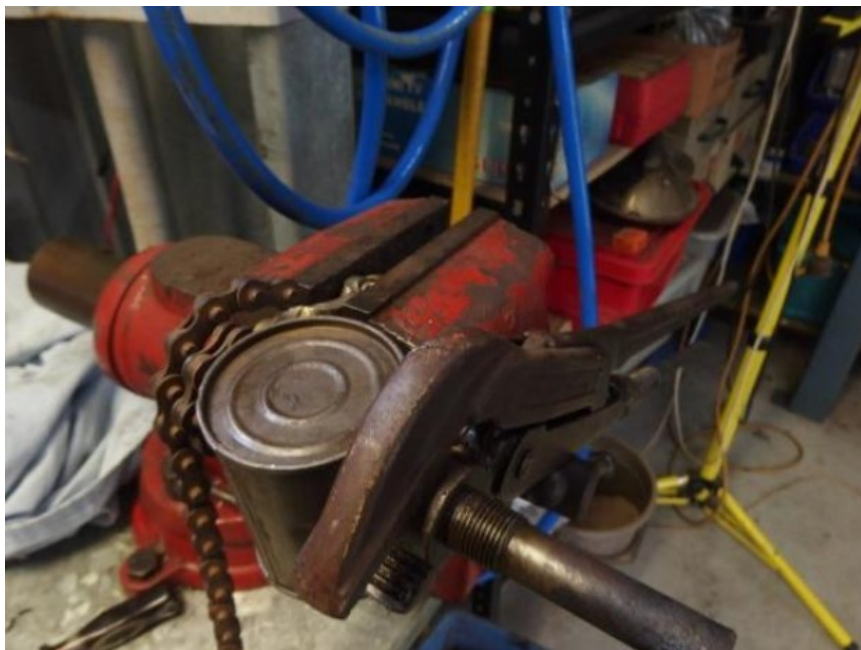
Tools used to disassemble master cylinder

The master cylinder was next removed and cleaned up, and currently I am working through sourcing replacement parts. I can get new hoses made locally with some difficulty, using the existing hose ends, due to BSF threads on ends. The master cylinder is available new from G.B for **£333!** The existing master cylinder therefore stripped with some difficulty, and a local brake shop has undertaken to have it re-sleeved, including detaching and re-soldering the tin reservoir

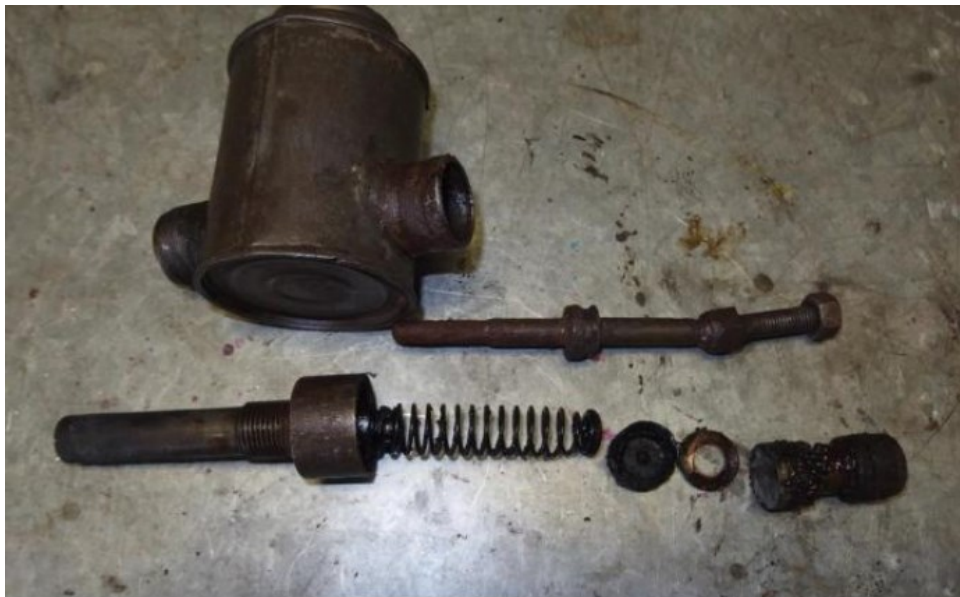
Master cylinder parts after strip down
