Morris 8 - Box Spanners - Tommy Bar - Tool Bag

This article features the last of the tools within the Morris 8 tool bag, and takes a close look at the cloth tool bag.

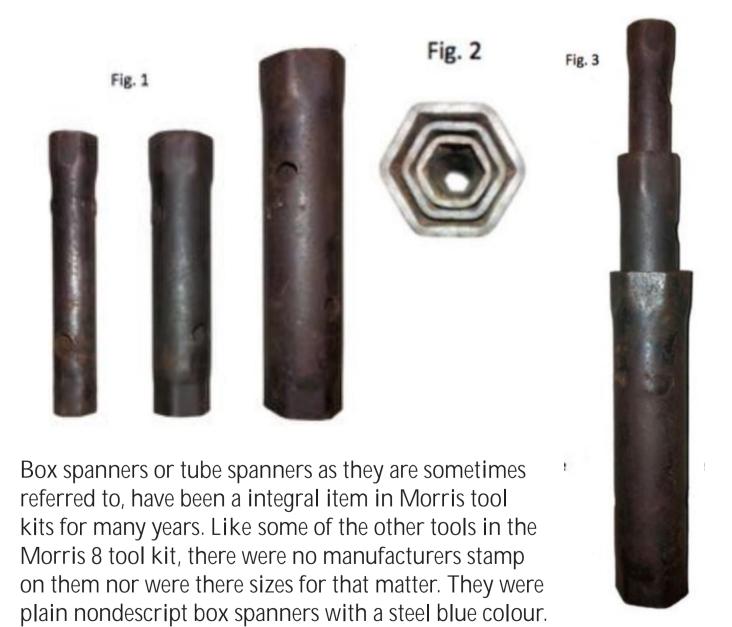
One nice design feature of the box spanners was that

they were designed to fit inside each other (nesting) (see figs. 2 & 3), much like a set of Russian dolls.

All box spanners had two 8.5mm diameter holes that went right through the side of the tube. This allowed a tommy bar to be inserted to give leverage for turning. The positions of these holes vary slightly but are approximately 1 1/8" (28mm) from either end of the tube for the 4" box spanners, and 1 1/2" (38mm) from either end for the 5" box spanner. If you are after a set of box spanners and aren't too worried about originality, UK Morris Register member Tim James wrote to say that Melco in the UK sell Whitworth box spanners. I'm not sure if they are the nesting type, but the cost is between £3.50 and £5 each.

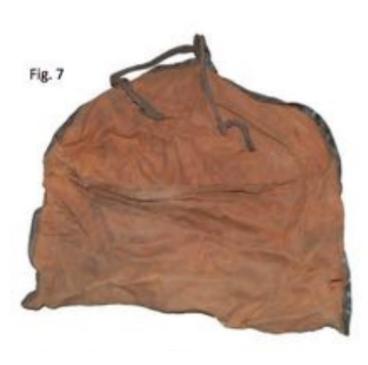
The tool bag (fig. 7) was a simple design made from a light weight cotton twill, with a leatherette/ rexine binding and cotton ribbons/straps to tie it into a roll. Dimensions vary between the two tool bags I have measurements for, so it is approximately 13 3/4" to 14 1/2" (350 - 370mm) wide and 12 1/4" to 12 1/2" (311 - 317mm) high when open. I would describe the colour of the roll as cocoa brown. The binding around the edge is black although one owner of an original tool bag thought it may have originally been dark brown. The one inch cotton ties are black. I personally know of only four of these tool bags left in existence, one in New Zealand, one in Australia and two in the UK. I would be very pleased if any reader could let me know of any others that have survived the passage of time.
